The role of hygienic design in chocolate production safety

Dr. Matilda Freund

Vice President, Global Food Safety

October 2022

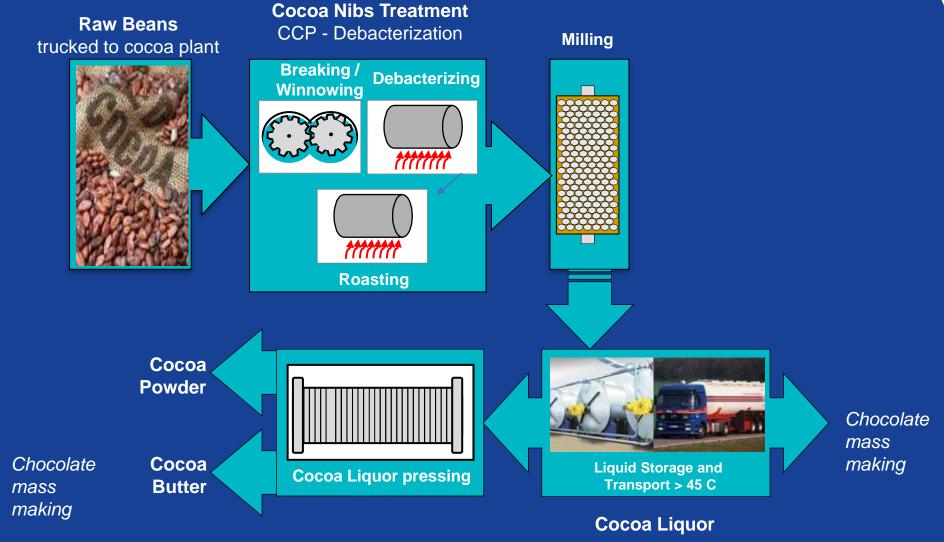
Cocoa process

Cocoa beans to cocoa liquor, cocoa butter & cocoa powder

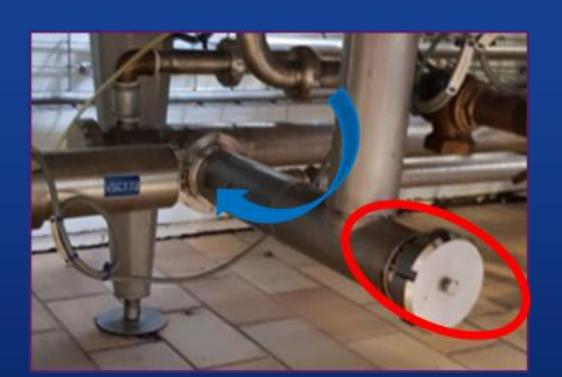
Dead end/legs

- Situation: Contamination in line reoccurring sporadically.
- Root cause: Line not able to fully flushed due to the presence of dead legs.
- Engineering not fully removing old lines or installing poorly designed lines that do not meet EHEDG guidelines.
- Additionally, drawings are often not updated. Shared lines not identified.
- Ensure proper installation and removal of lines.
- Update engineering drawings.
- Conduct studies to determine amount of flush needed to "clean" line.
